## TRAFFIC COLLISION AVOIDANCE SYSTEMS (TCAS)

### Satimboyev Ozodbek

The 4-th year student of tashkent state transport university Shukurova Saboxat Muradjanovna - scientific supervisor

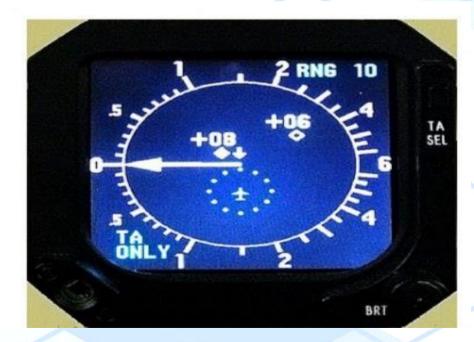
Picture 1: TCAS indicator

The TCAS operates by continuously scanning the airspace around the aircraft and identifying potential conflicts with other aircraft that are equipped with a transponder. It then provides a warning if there is a risk of collision, and displays commands to the pilot on their cockpit display to avoid the conflicting aircraft.

The TCAS interface with the pilots is provided by two displays: the traffic display and the RA display. These two displays can be implemented in a number of ways including displays that incorporate both displays into a single, physical unit. Regardless of the implementation, the information displayed is identical. The standards for both the traffic display and the RA display are defined in DO-185A.
